**INF.1**

**RID: 11<sup>th</sup> Meeting of the Working Group on Tank and Vehicle Technology**  
(Berne, 18 and 19 May 2010)

**Subject: End Protection Measures on Rail Tank Wagons**

**Transmitted by the United Kingdom**

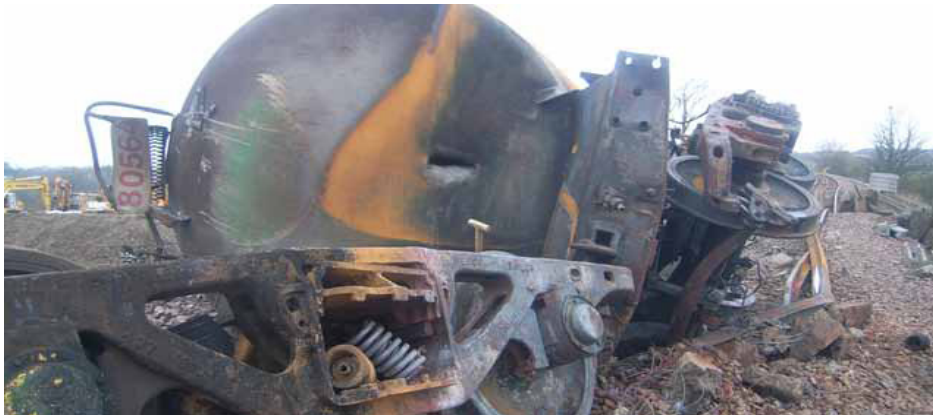
Wagon 10

5. The report concludes that all of the fuel lost from tanks on three of the wagons (170,000 litres) was due to significant override movements which resulted in punctures to the tanks made by the drawhooks of adjacent wagons. Images of these punctures can be seen below:

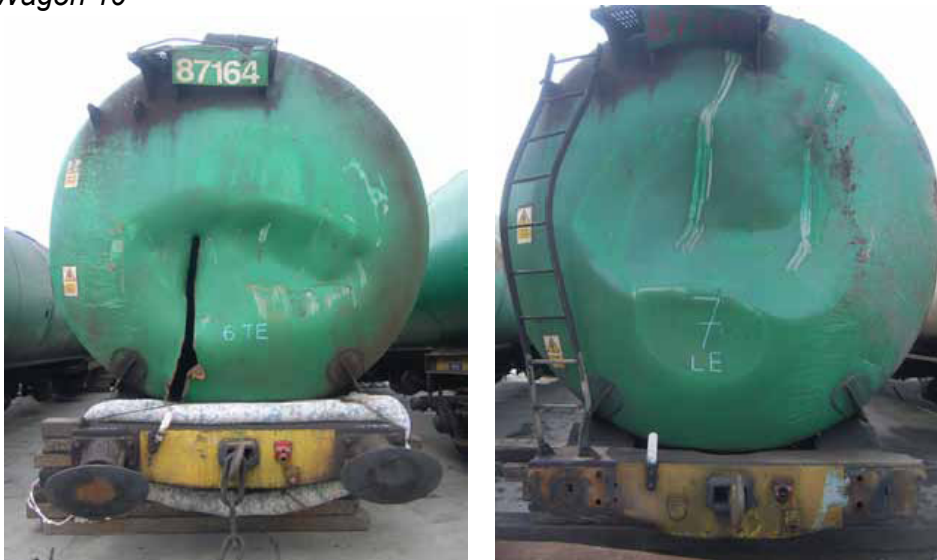
Vertical gash on the tank of wagon 6 (left) caused by the adjacent drawhook on wagon 7 (right)
