1. Mode	
<input checked="" type="checkbox"/> Rail Wagon number (optional): 80 88 7850 5102	<input type="checkbox"/> Road Vehicle registration (optional):

2. Date and location of occurrence	
Year: 2004 Month: 04 Day: 05 Time: 08:18	
<input type="checkbox"/> Station <input checked="" type="checkbox"/> Shunting/marshalling yard <input type="checkbox"/> Loading/unloading/transshipment site Location / Country: Bruges (Belgium) or <input type="checkbox"/> Open line Description of line: Kilometres:	<input type="checkbox"/> Road <input type="checkbox"/> Built-up area <input type="checkbox"/> Loading/unloading/transshipment site <input type="checkbox"/> Open road Location / Country:

5. Description of occurrence	
<input type="checkbox"/> Derailment/Leaving the road <input checked="" type="checkbox"/> Collision <input type="checkbox"/> Overturning/Rolling over <input type="checkbox"/> Fire <input type="checkbox"/> Explosion <input checked="" type="checkbox"/> Loss <input type="checkbox"/> Technical fault Additional description of occurrence: During a shunting operation (backing movement of a group of wagons by a locomotive) the group of wagons was mistakenly shunted onto an occupied track.

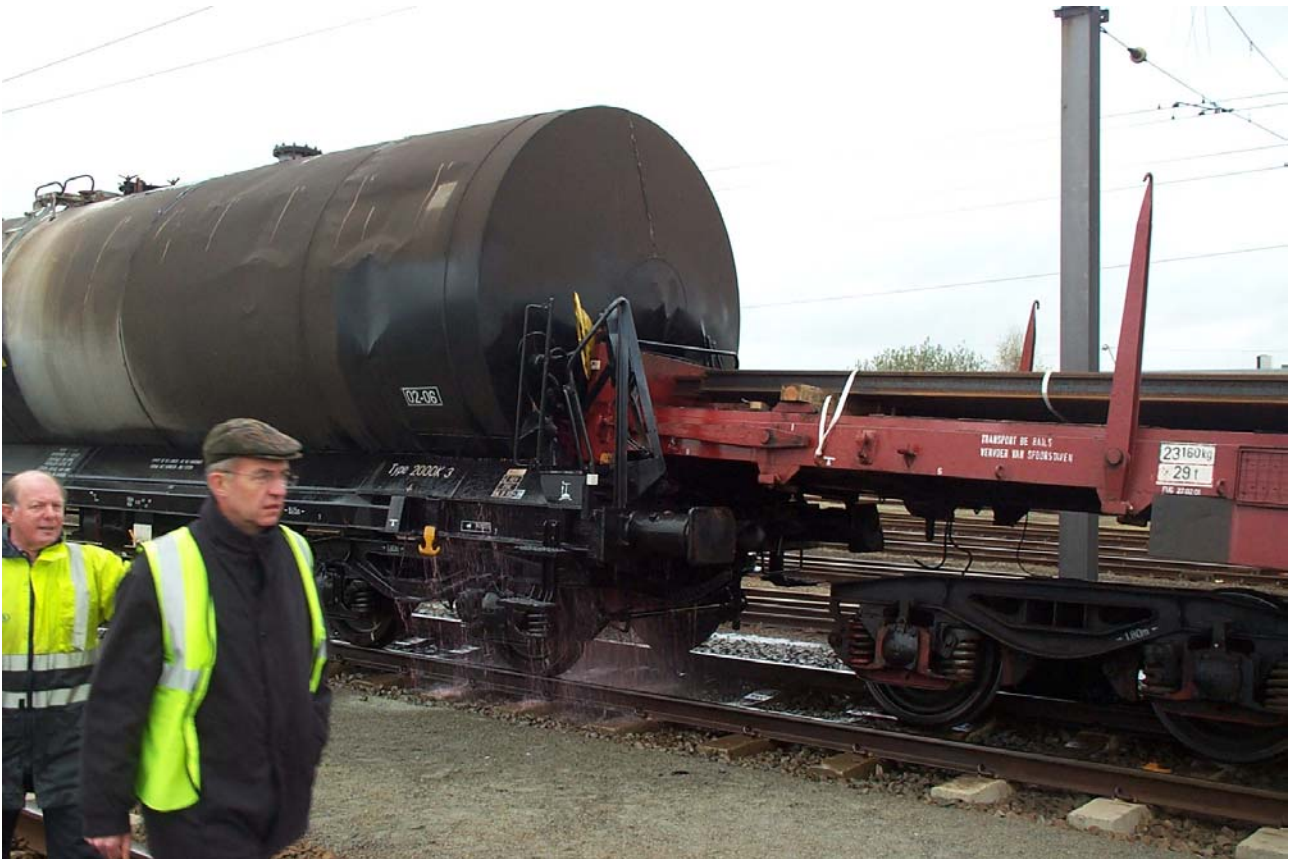
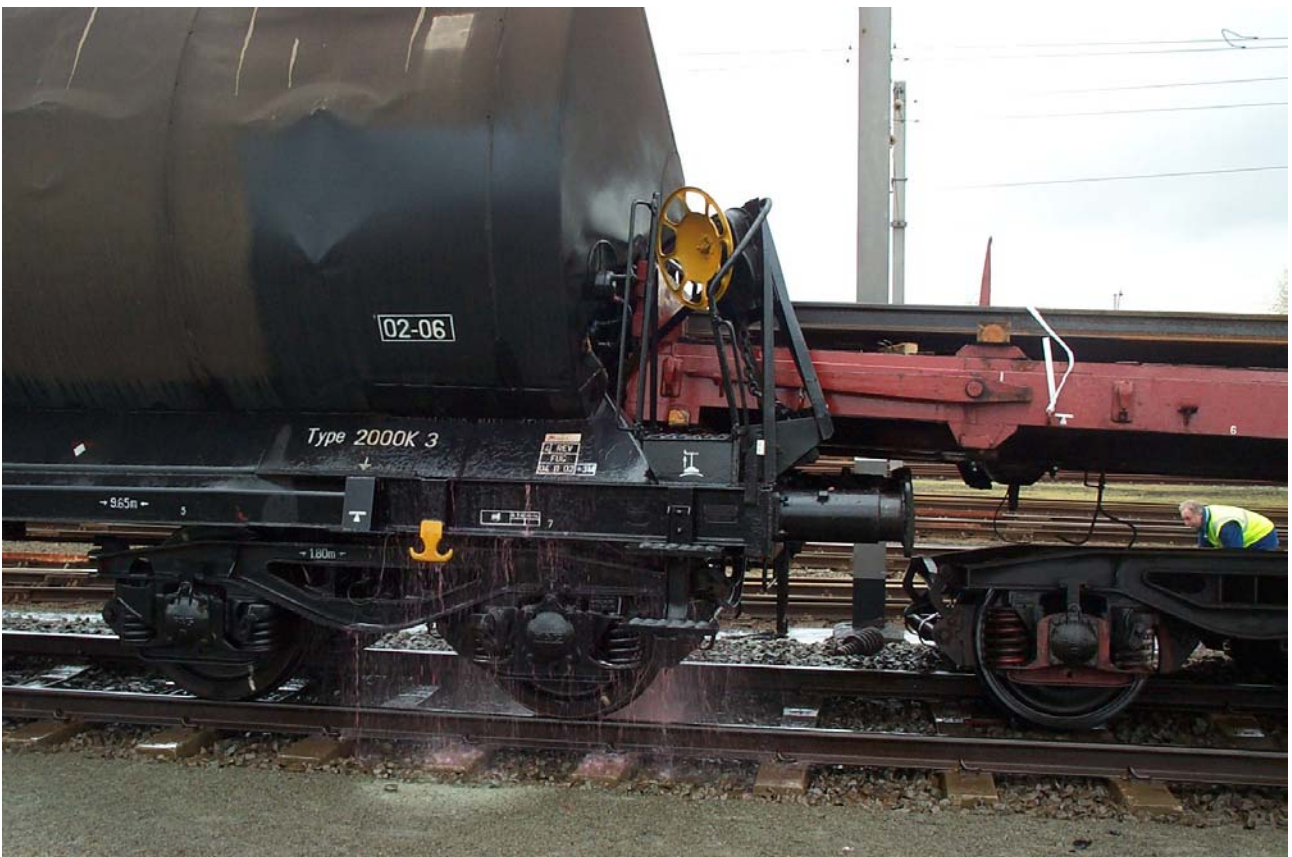
Damaged tank-wagon immediately after the accident

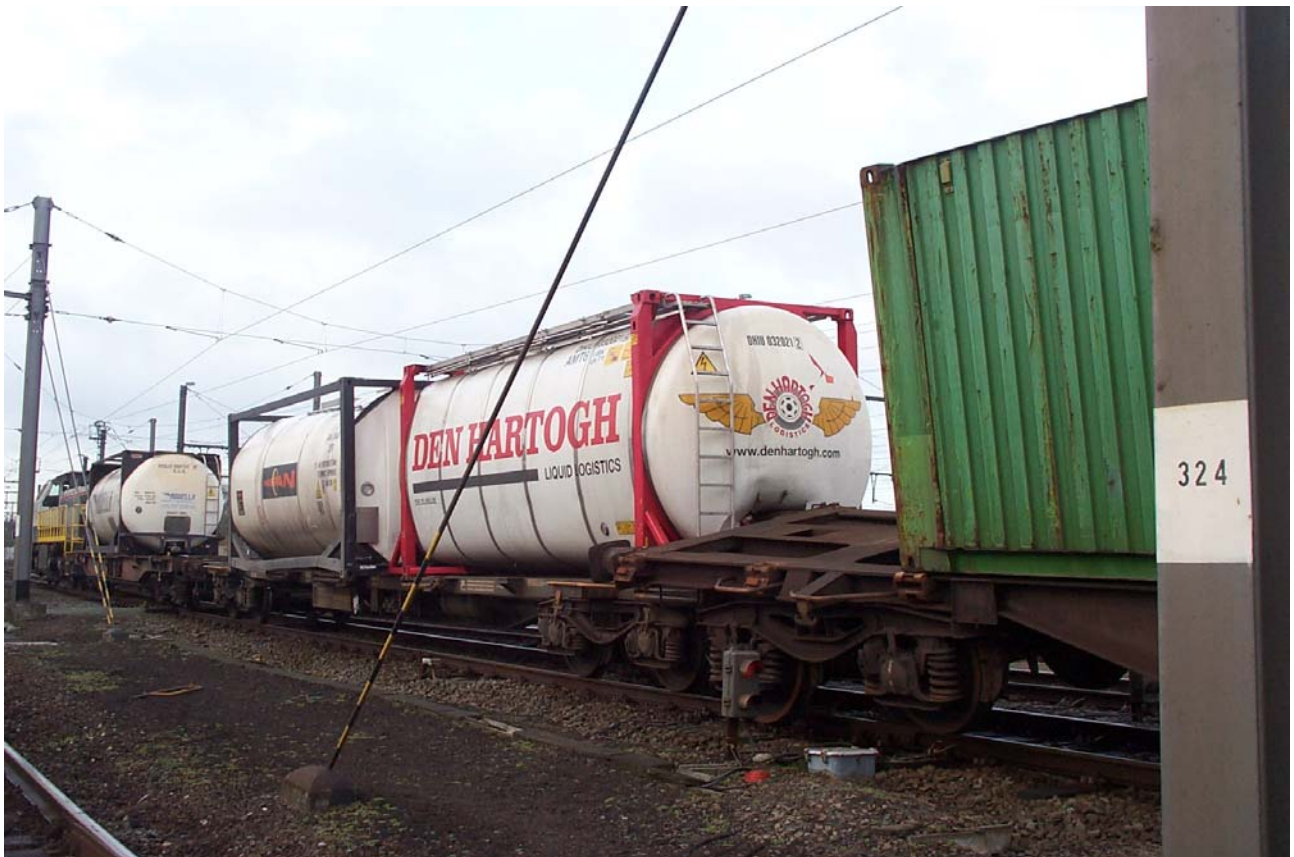
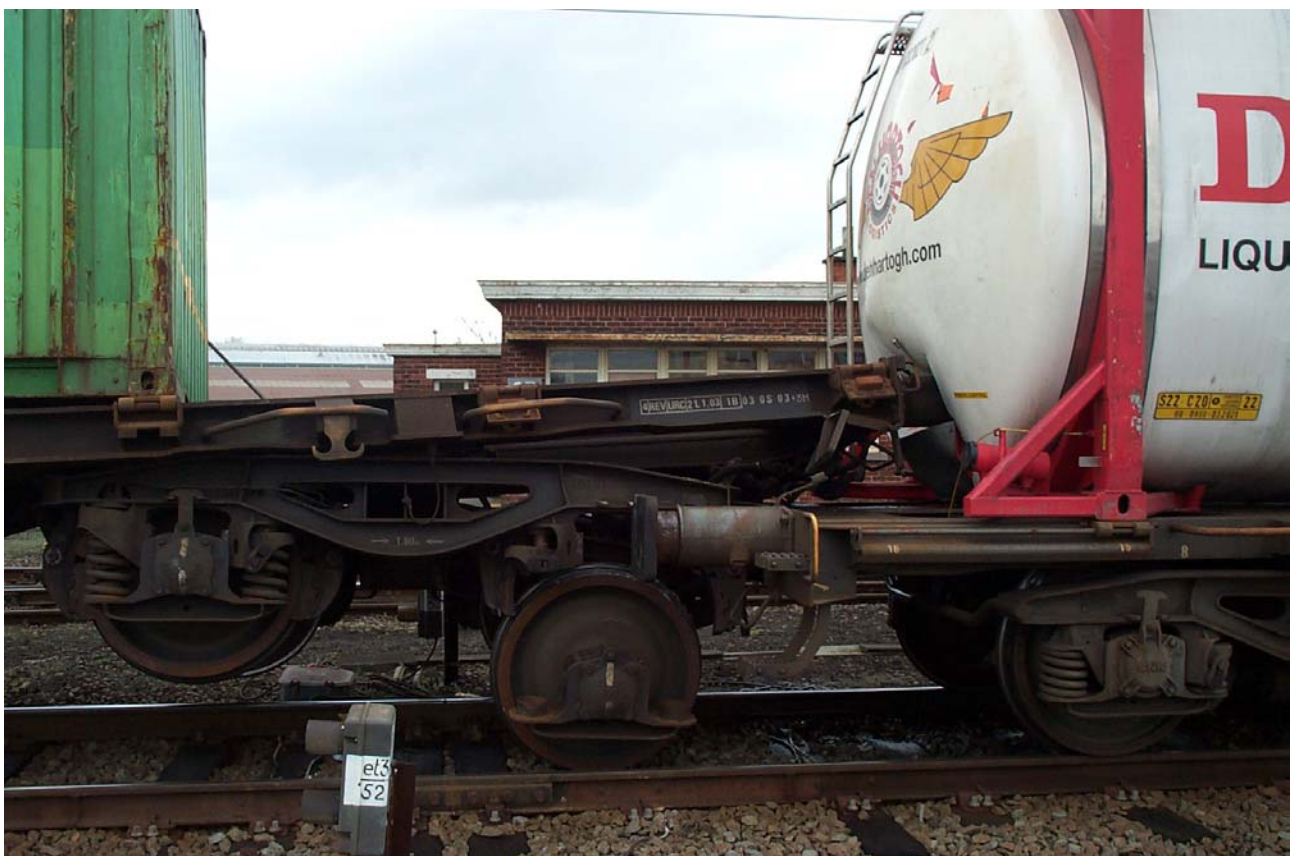
A tank-container damaged in the same accident. It contained a substance which is not subject to RID (butylcarbitol).

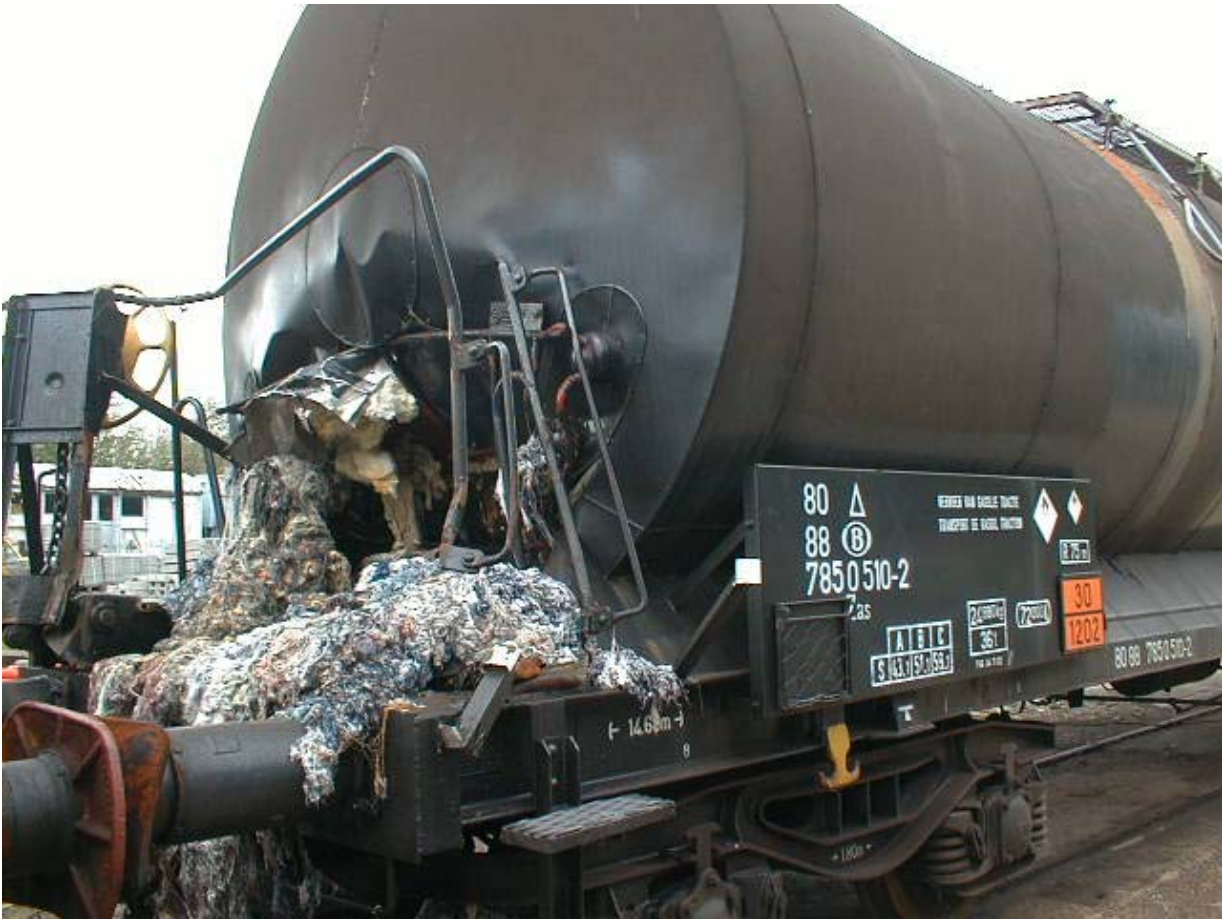
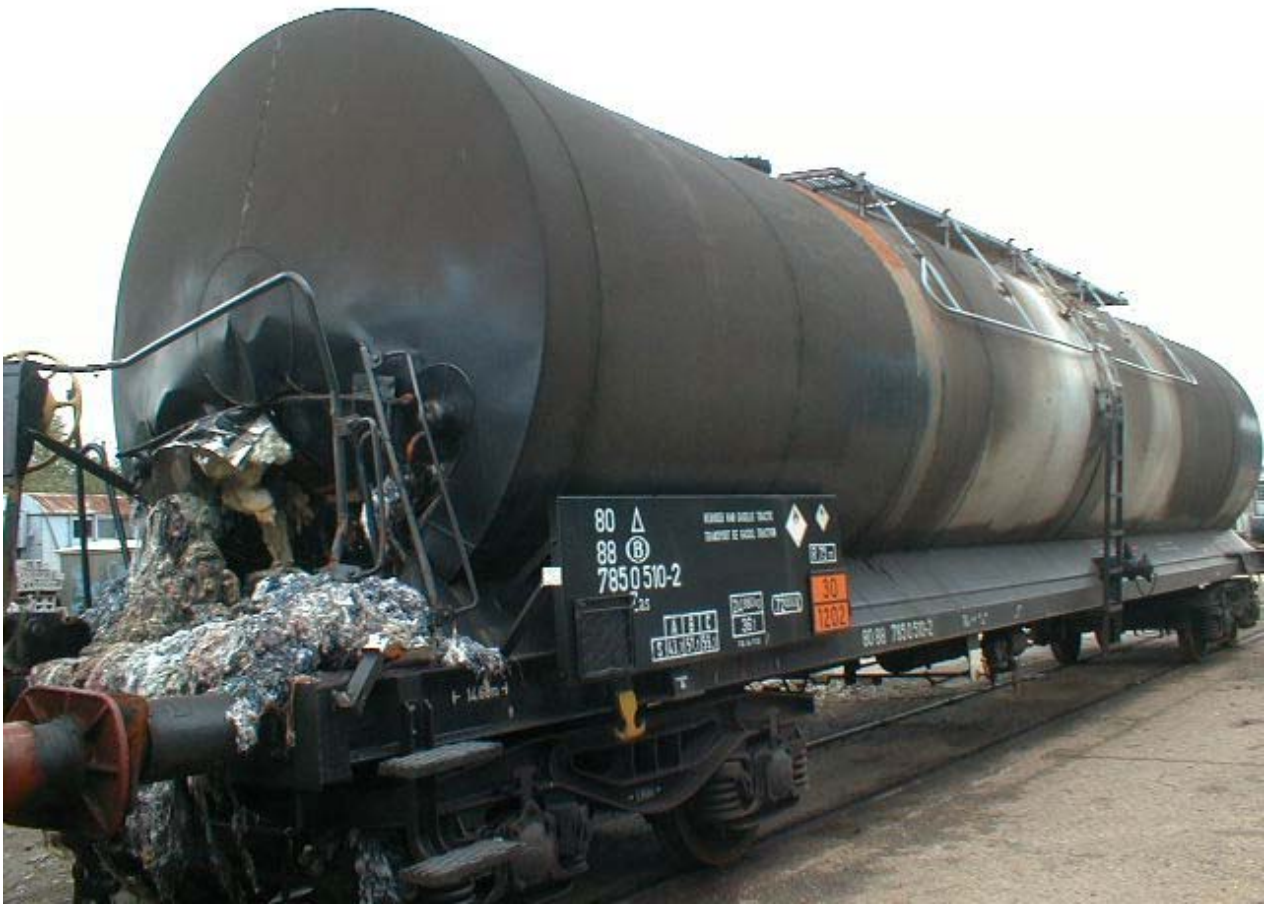
Damage (rupture) to the tank (after clearing work was completed)

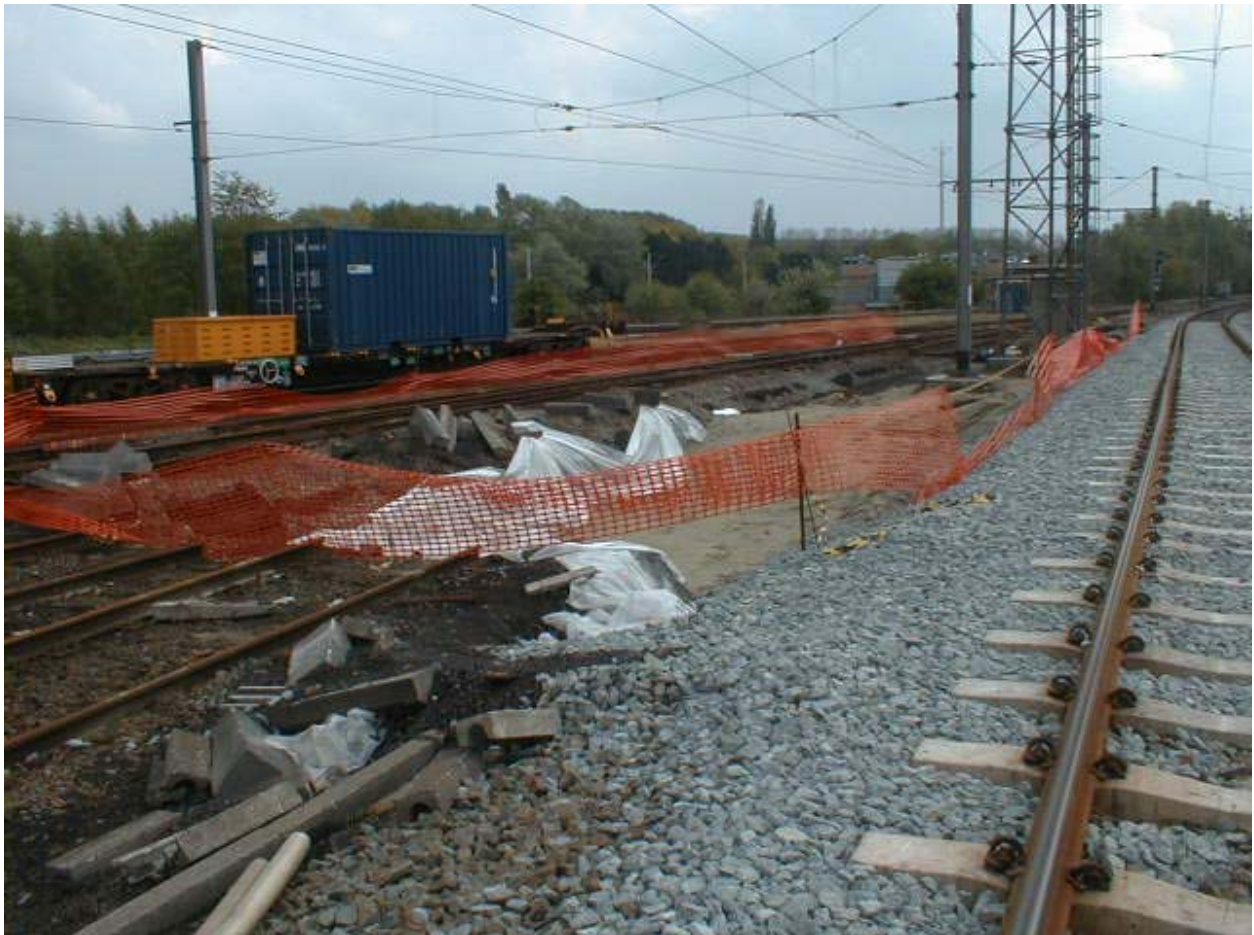
Scene of the accident once the contaminated soil had been excavated
