Investigation into the cause of the leakage of a tank wagon filled with Acrylic nitrile on 20 August 2002 in Amersfoort

Contract-issuing party: Council for Transport Safety

Reference no. : AEAT/02/2600084/004

Date : November 2002

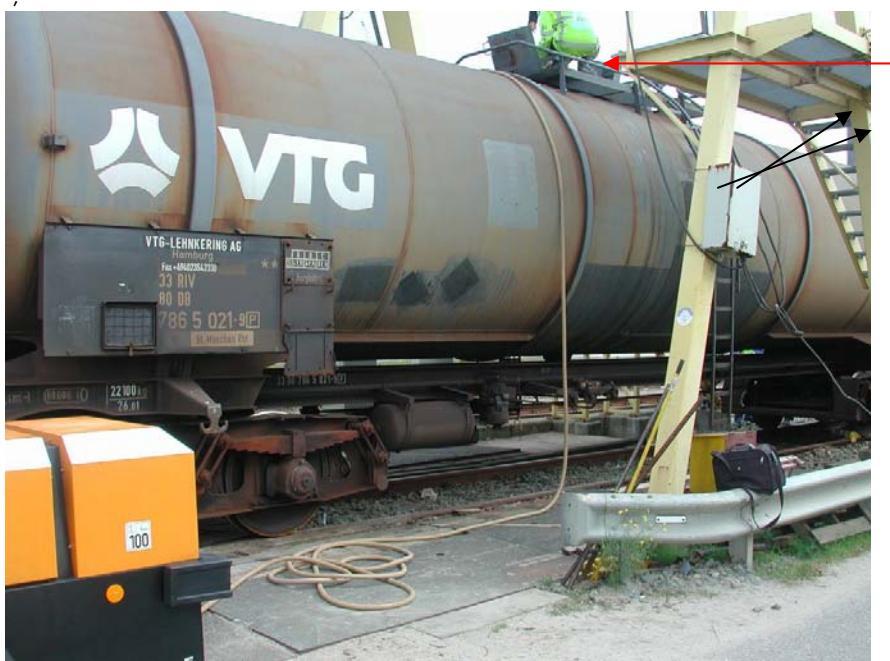
The wagon in question was a liquid tank wagon with top discharge. On tank wagons of this type, there are no openings or appendages below the liquid level in the tank walls, see photograph 1.

Photograph 1: the liquid tank wagon on which the leakage occurred.

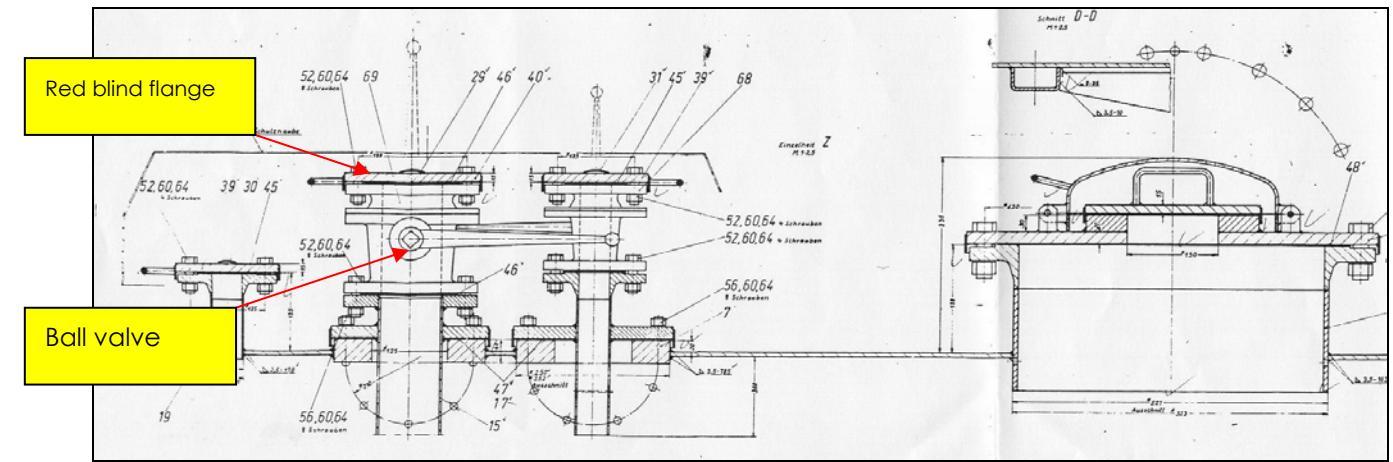
There are 3 openings on this tank wagon; the central opening with the red blind flange and ball valve discharges into the riser tube, which reaches to the ground, see figure 1 and photograph 2. By applying gas pressure to the tank, the tank can be discharged via this riser tube. The pipe can also be used for filling the tank.

Figure 1: drawing of the appendages on the top of the tank.

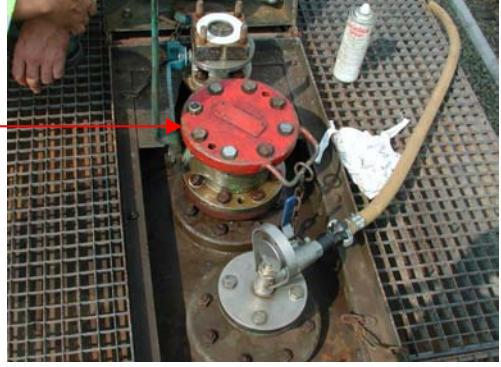
Following reporting, it was determined by the emergency services in situ that the red blind flange on the valve of the filler pipe had leaked, see photograph 2.

Photograph 2: leakage at the location position as of the red blind flange.

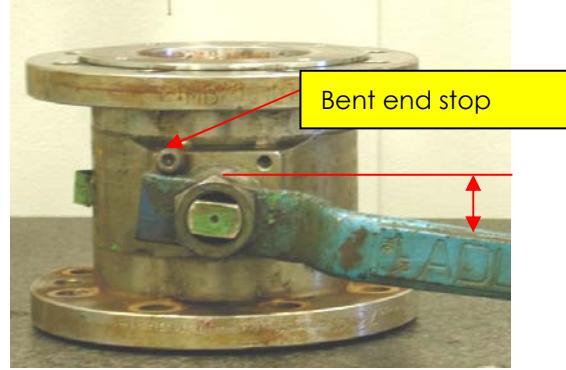
The handle of the ball valve beneath the red blind flange was not in the horizontal position (horizontal is closed) but had been turned slightly further downwards, see photograph 3. The handle could be pushed further, because the end stop was bent, see photograph 4. Further investigation by AEAT Rail BV showed that the material beneath the end stop (M8 bolt) is deformed, see photograph 5.

Photograph 3: handle in the

as identified in Amersfoort, due to the bent end stop.

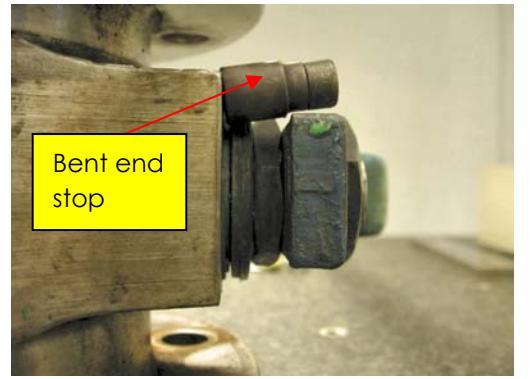
Photograph 4: bent end stop, side view.

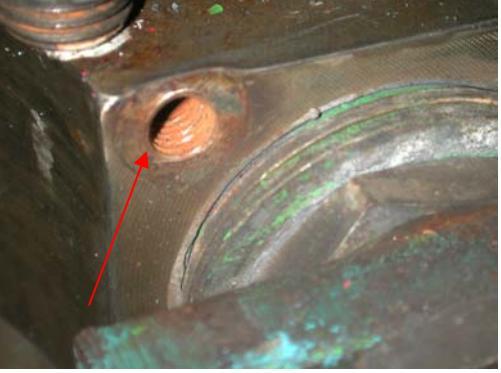
Photograph 5: the deformed material beneath the end stop.

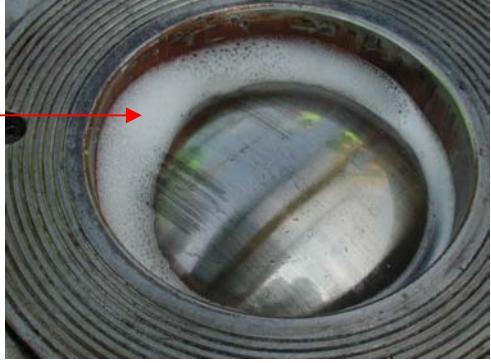
<u>With measurement 1</u>, using a soapy solution, it was determined that the ball value in the closed position (handle horizontal) leaked at an overpressure of 0.3 bar. See photograph 6.

Photograph 6: leakage of the ball valve visible with soapy solution.

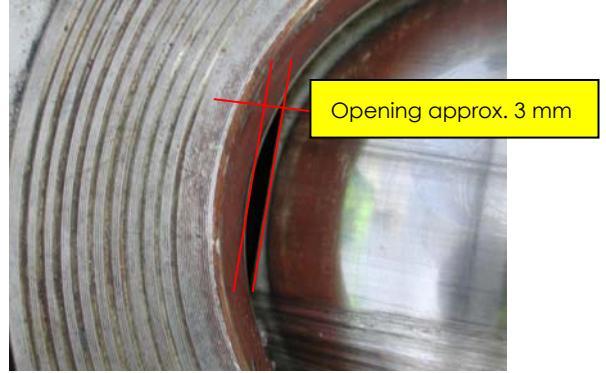
Photograph 7: ball which in the handle position does not shut off the opening.

<u>With measurement 2</u>, it was determined that the ball valve with the handle in the position as found in Amersfoort (against the bent end stop) leaked very severely because in this position, the ball does not shut off the opening, a gap of approx. 3 mm was still visible. See photograph 7.

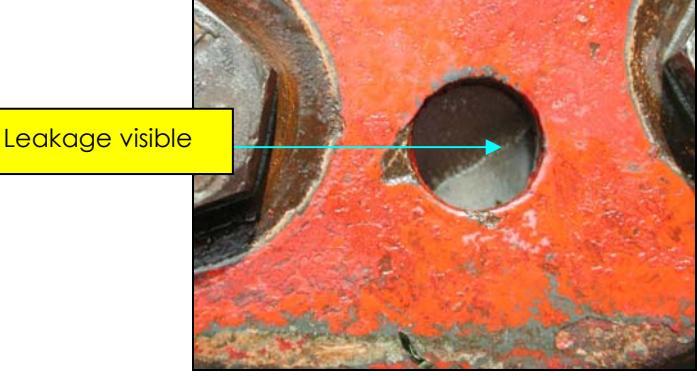
By listening close to the blind flange, it was possible to determine that leakage did occur.

Only once the pressure in the tank wagon was raised to approx. 1.5 bar could it be determined using a soapy solution, with considerable effort, that leakage occurred.

Photograph 8: leakage was visible in the open hole in the blind flange.

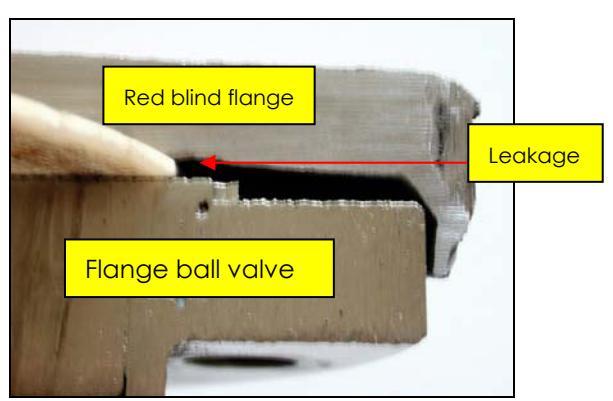
<u>With measurement 3</u>, with the ball valve open and the red blind flange fitted, it was determined that the red blind flange leaked. Using a soapy solution, it was not possible to determine that a leak occurred. This is because the blind flange is fitted (for safety reasons) with a welded protruding edge, so that it was not possible to look directly between the two flanges, see photograph 9. In addition, the soapy solution did not reach the correct point.

Photograph 9: cross-section of the red blind flange and the ball valve flange.

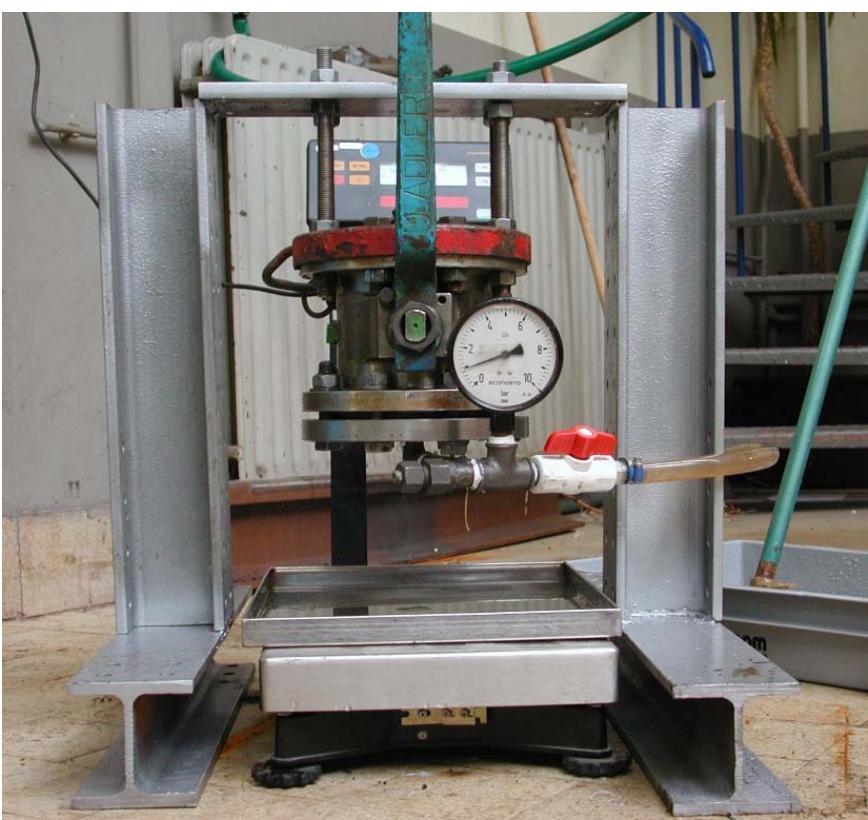
water pressure of 1 bar. The measured water leakage at 1 bar overpressure was 40 g per minute, i.e. 2400 g or 2.4 litres per hour. This is the leakage under the most favourable circumstances. It may be assumed that the leakage in practice was greater.

Photograph 10: Test bench for determining leakage between the flange on the ball valve and the blind flange.

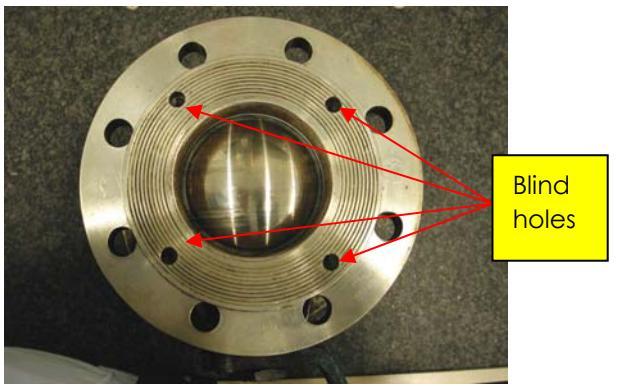
There are 4 blind holes in the gasket face of the flange, see photograph 12. On the drawings, see appendix 1, of the ball valve as received from VTG, <u>no blind holes</u> are shown in the gasket face.

Photograph 12: top view of flange with 4 blind holes.

These blind holes reduce the actual effective gasket area by approx. 70%.

- A shutoff valve should be used without the blind holes found in this case. As a result, the gasket face becomes larger and the risk of leakage is considerably reduced.

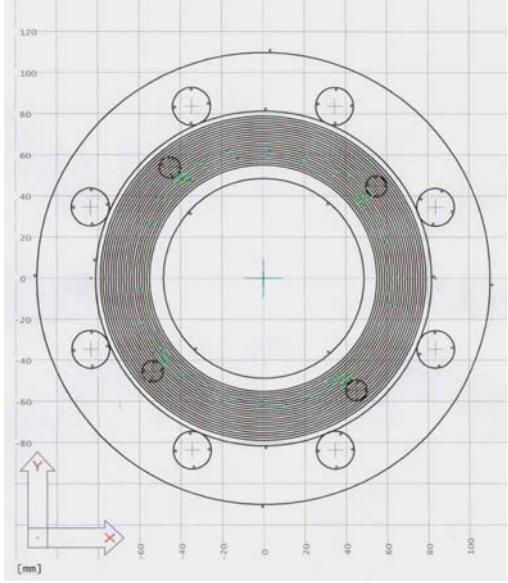
The flange was correctly flat, with a maximum deviation across all measuring points of 0.06 mm.

It was determined that the gasket face of the flange was slightly angled outwards to inwards, by approx. 0.03 mm, see figures 2 and 3. All other measurement sheets have been enclosed as appendix 2.

Figure 2: measurement sheet for the flange of the ball valve.

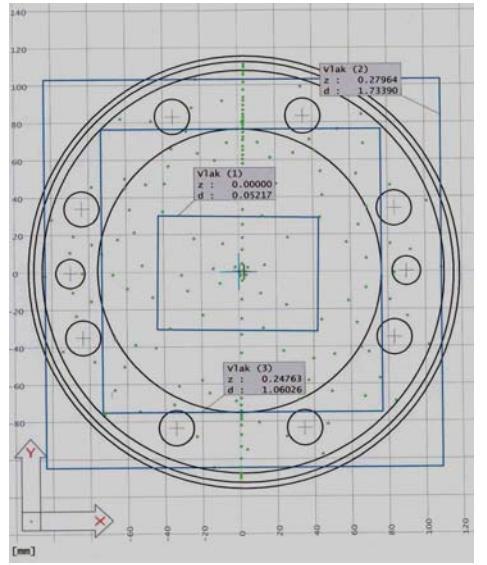
The blind flange was also measured on the 3D bench, at 53 points on the gasket face. The maximum deviation was 1.6 mm, see figure 4. All measurement sheets have been enclosed as appendix 2.

Figure 4: measurement sheet of blind flange. Figure 5: hatched area is effective gasket

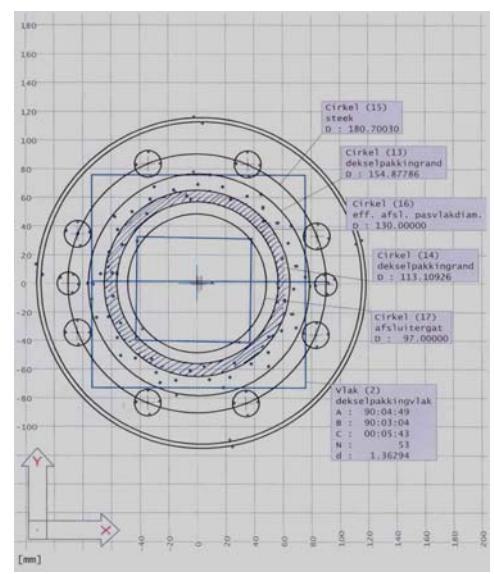
As a consequence, only a small part of the gasket face of the blind flange is actually effective; see the hatched ring on figure 5.

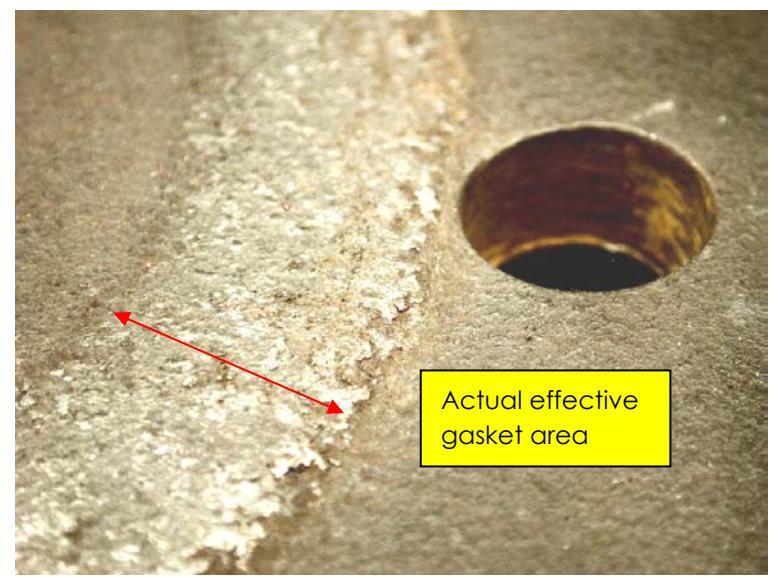
Photograph 13: actual effective gasket area.

The total surface on the inside of the blind flange was rusted, and on the gasket face itself there was a relatively thick layer of rust and old gasket material.

The gasket face is higher than the rest of the blind cover, see photograph 13. The blind holes on the flange on the valve are just beyond this raised gasket face on the blind flange.

Due to the corrosion which occurred, the blind flange has only a relatively small remaining gasket area, see photograph 13. Due to the blind holes in the flange on the ball valve and the not perfect fitting of the gasket, only a small actual effective gasket area remains, see photograph 25.

- In our opinion, on a stainless steel ball valve a stainless steel blind flange should be fitted, certainly if used with corrosive products of this kind. No welding should be carried out on a valve.

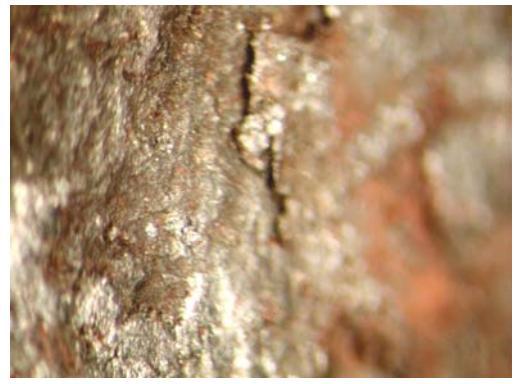
The surface quality of the blind flange was examined microscopically, see photographs 14 to 17, which were made with different magnifications. Photograph 17 is a view slightly at an angle to the surface, clearly showing that the layer on the gasket face of the blind flange is porous.

Photograph 17: magnification 40x.

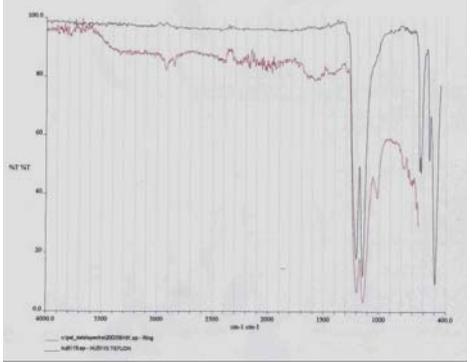
Using infrared spectrometry, the gasket material was examined, see the infrared spectrum in figure 6. The red line in the spectrum shows the gasket material, the black line is a reference sample of Teflon. The peaks in the wave length area around 1250 cm-1 show that the gasket material is Teflon.

Figure 6: infrared spectrum of gasket material.

Teflon is resistant to acrylic nitrile, and is therefore suitable as a gasket for this application.

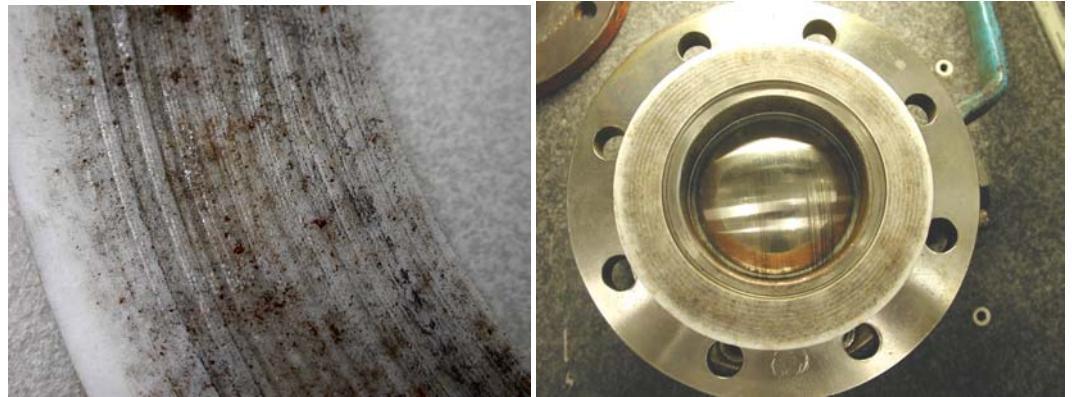
The surface appears normal, with some iron corrosion particles embedded locally. The material shows plastic deformation; the impression of the grooves on the flange of the ball valve is visible, see photograph 22. The impression of the grooves on the outside diameter is deeper than on the inside diameter, which indicates that the pressure on the gasket was higher, on the outside edge.

The dimensioning of the gasket is not ideal. The external diameter of the gasket is in fact slightly too large, as a result of which it was difficult to insert the bolts through the holes in the flange, see photograph 23.

The internal diameter is too large; the internal diameter of the gasket should be the same as the internal bore of the ball valve flange; the result is a greater gasket area.

Photograph 22: the gasket used in Amersfoort.

Photograph 23: gasket on the valve.

- The area of the gasket should be better matched to the dimensions of the valve, for the above described reasons.
- In our opinion, the checking of the shutoff devices as specified in the VSG/ RID 1.4.3.3 f, at the premises of the forwarder, is not or barely possible. We recommend that you investigate how these actions are currently carried out. A reliable measurement such as the measuring method using the soapy solution should be used, in our opinion. All the more because we expect that the situation with the two other blue blind flanges (gaseous phase) is not much better.

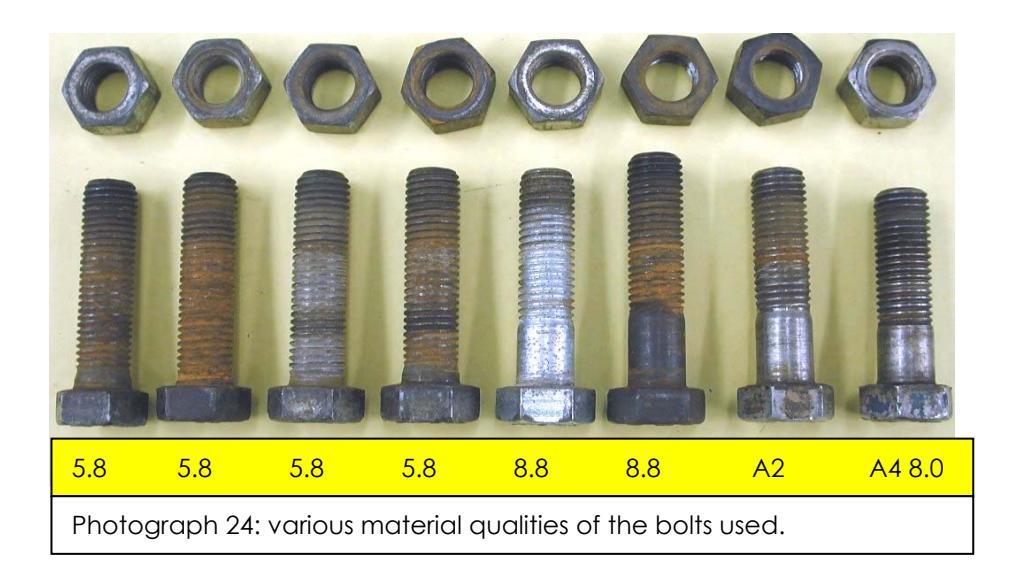
The bolts turn smoothly, but it is notable that various bolt types were used. The differences are in material quality, see photograph 24. In this application, the difference in material quality plays no role. The quality indication appears below the bolts. Carbon steel bolts were used, both zinc galvanised and non-zinc galvanised, and stainless steel bolts were also used.

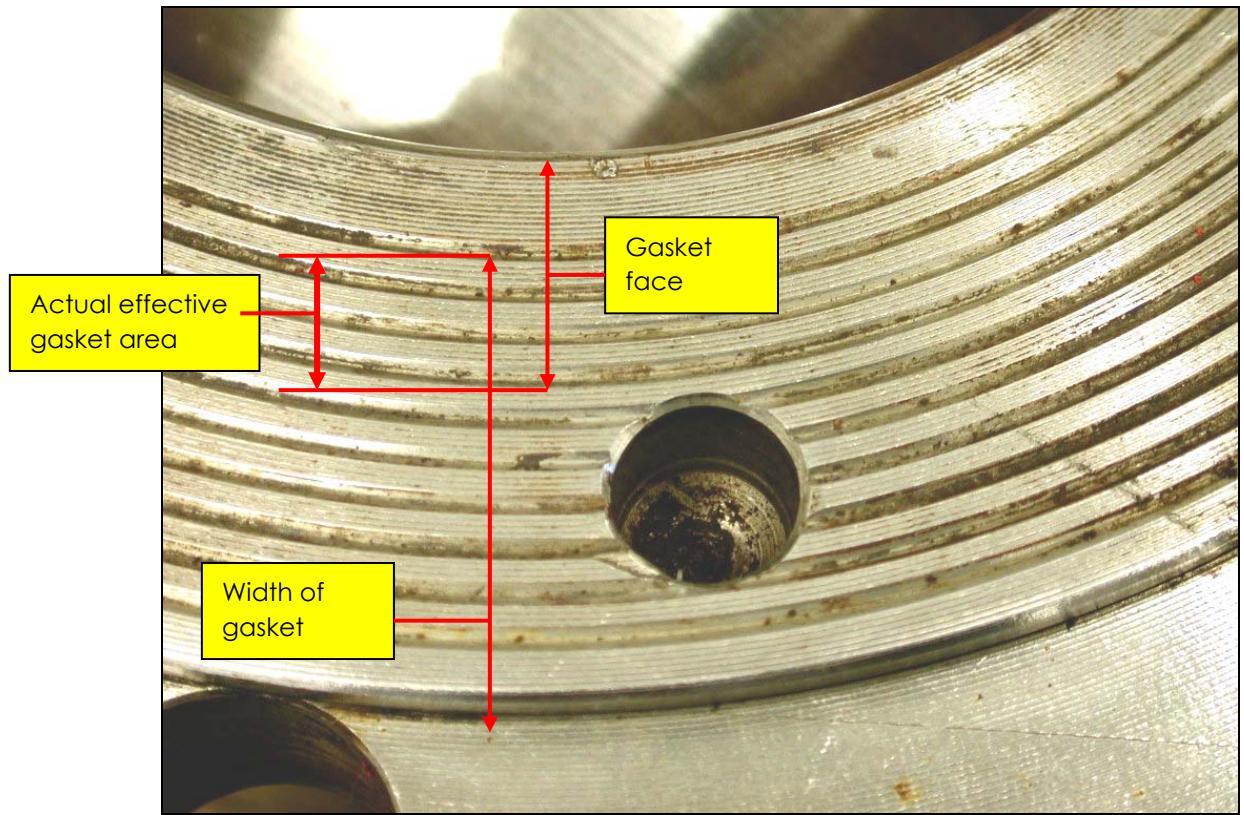
Photograph 25: actual effective gasket area.

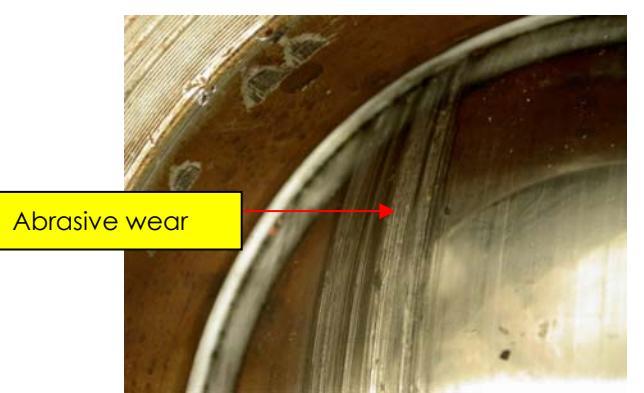
The cause of the non-sealing of the ball valve itself is easily visibly observable, with the handle in the horizontal position. The ball of the valve is damaged due to abrasive wear, see photograph 26. This form of wear is caused by hard particles. To determine the origin of these particles, the ball valve was sawn through, see photograph 27.

Photograph 26: abrasive wear of the ball.

- A good inspection protocol for the ball valve should be introduced. Both of the defects discovered were clearly visually observable.

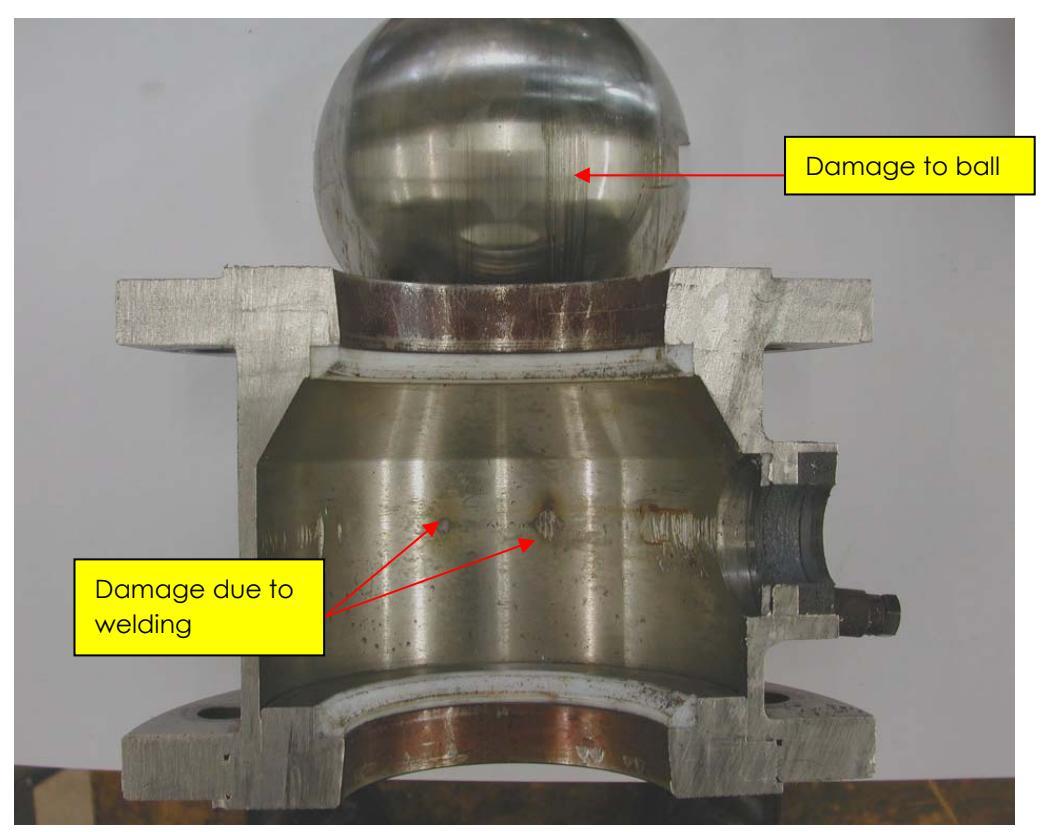
Photograph 28: damage to the valve housing due to the welding on of a manufacturer's plate. The position precisely matches the damage to the ball.

Once the ball had been sawn through, damage was found in the ball valve housing, at the precise location of the damage to the ball, see photograph 28. This damage to the housing of the ball valve was caused by the welding of a name plate onto the valve, see photograph 29. More burn-in points and abrasive wear points were found on the ball, see photograph 30. All this points towards the fact that during welding, the earthing terminal was placed on the handle, as a result of which sparkover occurred via the ball to the valve housing, leading to the ball becoming welded tight. Once these micro-welds broke free, rough, hard points occurred, which caused the wear identified.

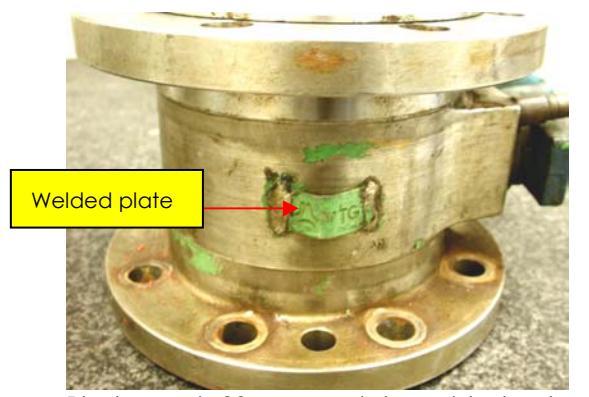
Photograph 29: name plate welded onto the valve.

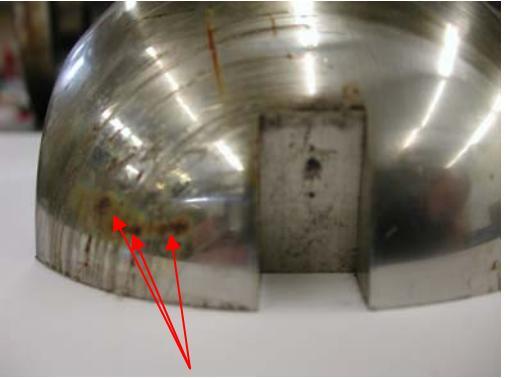
Photograph 30: more burn-in points on the ball.
