Investigation into the cause of the leakage of a tank wagon filled with Acrylic nitrile on 20 August 2002 in Amersfoort

Contract-issuing party: Council for Transport Safety

Reference no. : AEAT/02/2600084/004

Date : November 2002

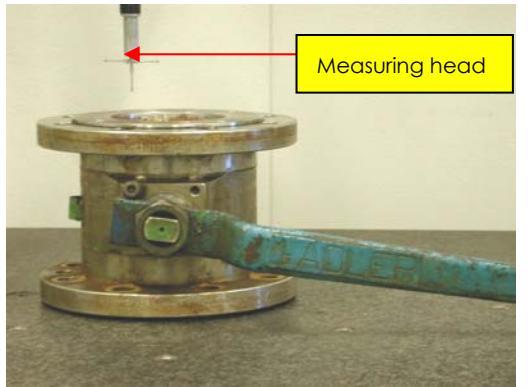
Photograph 11: valve on the 3D bench.

To be able to determine whether the flange on the ball valve and the blind flange are flat, both parts were measured on a 3D measuring bench, see photograph 11.

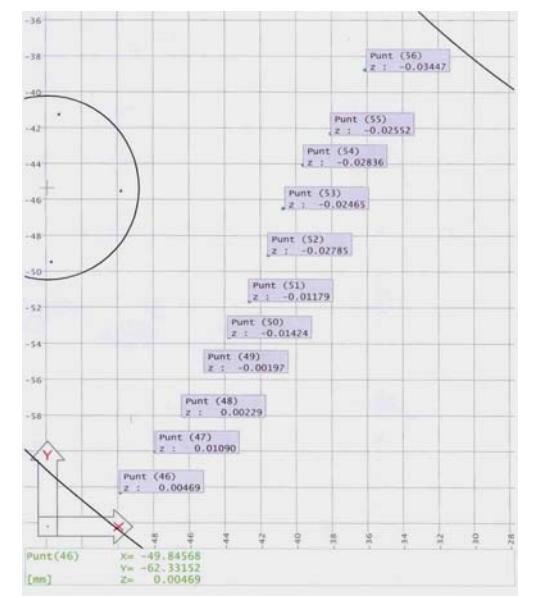
Figure 3: detail of measurement sheet, measurement across the width of the gasket face.

It was determined that the gasket face of the flange was slightly angled outwards to inwards, by approx. 0.03 mm, see figures 2 and 3. All other measurement sheets have been enclosed as appendix 2.

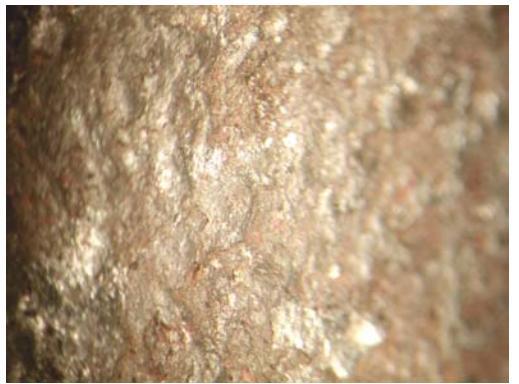
Photograph 14: magnification 10x.

The surface quality of the blind flange was examined microscopically, see photographs 14 to 17, which were made with different magnifications. Photograph 17 is a view slightly at an angle to the surface, clearly showing that the layer on the gasket face of the blind flange is porous.

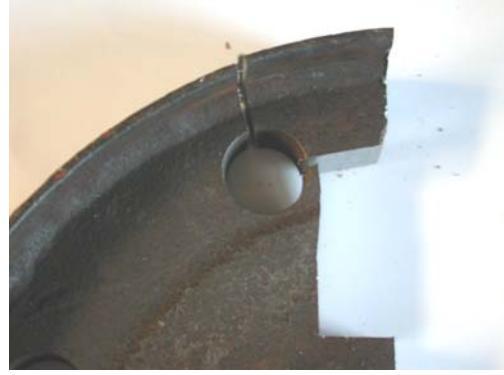
The blind flange was sawn through and at the saw cut, a preparation was removed, in order to show the rust layer. See photograph 18.

Photograph 18: section removed for 20X. microscopic investigation.

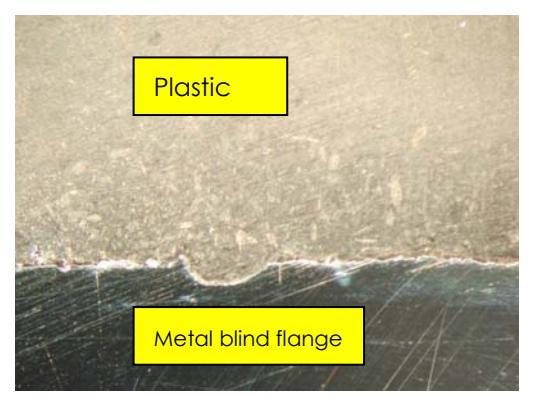
Photograph 19: magnification

The material removed was embedded in plastic, ground and polished, so that the cross-section could be examined under the microscope, see photographs 19, 20 and 21.

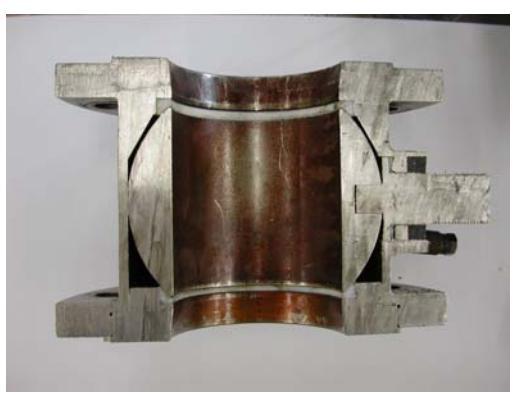
The cause of the non-sealing of the ball valve itself is easily visibly observable, with the handle in the horizontal position. The ball of the valve is damaged due to abrasive wear, see photograph 26. This form of wear is caused by hard particles. To determine the origin of these particles, the ball valve was sawn through, see photograph 27.

Photograph 27: cross-section of ball valve.

- A good inspection protocol for the ball valve should be introduced. Both of the defects discovered were clearly visually observable.
